POINT RUSTON

RE: Monthly Report: No. 204, May 2013
Operable Unit No. 02 - Asarco Tacoma Smelter Site

Monthly Report 204, May 2013
Operable Unit 02
Asarco Tacoma Smelter Site

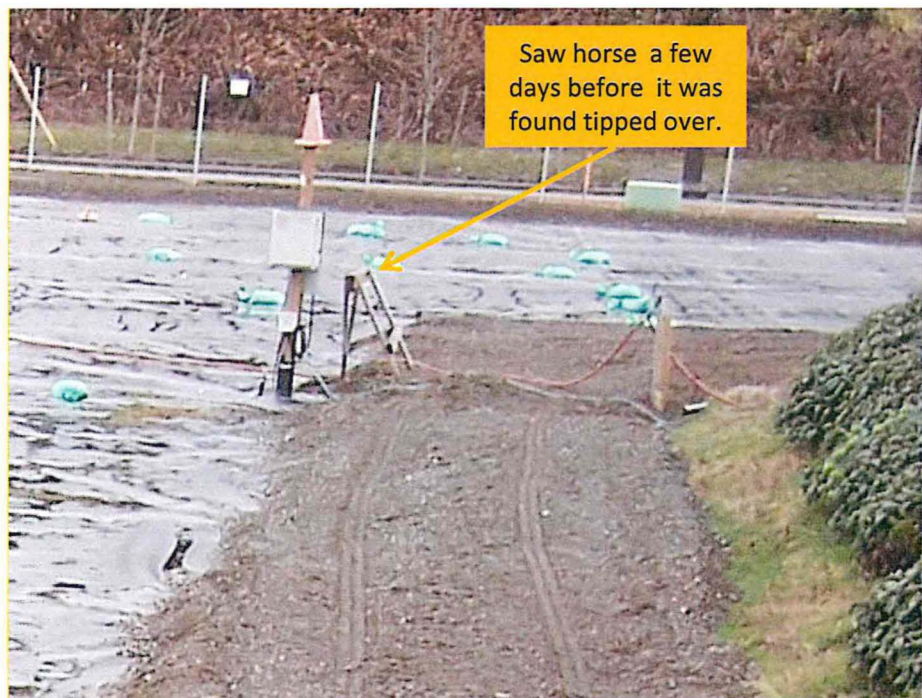
Saw horse a few days before it was found tipped over.

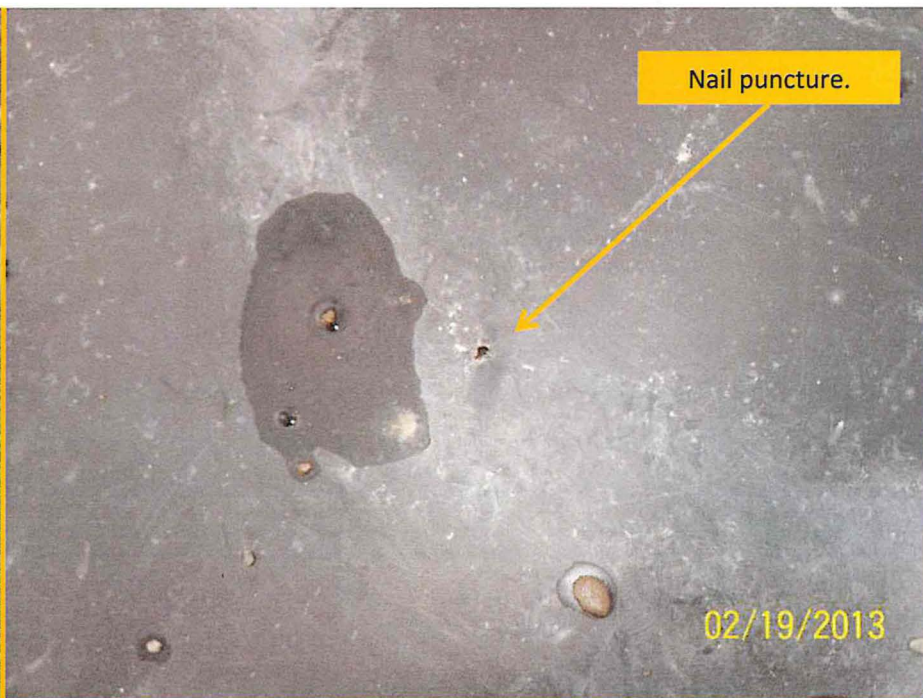
Nail puncture.

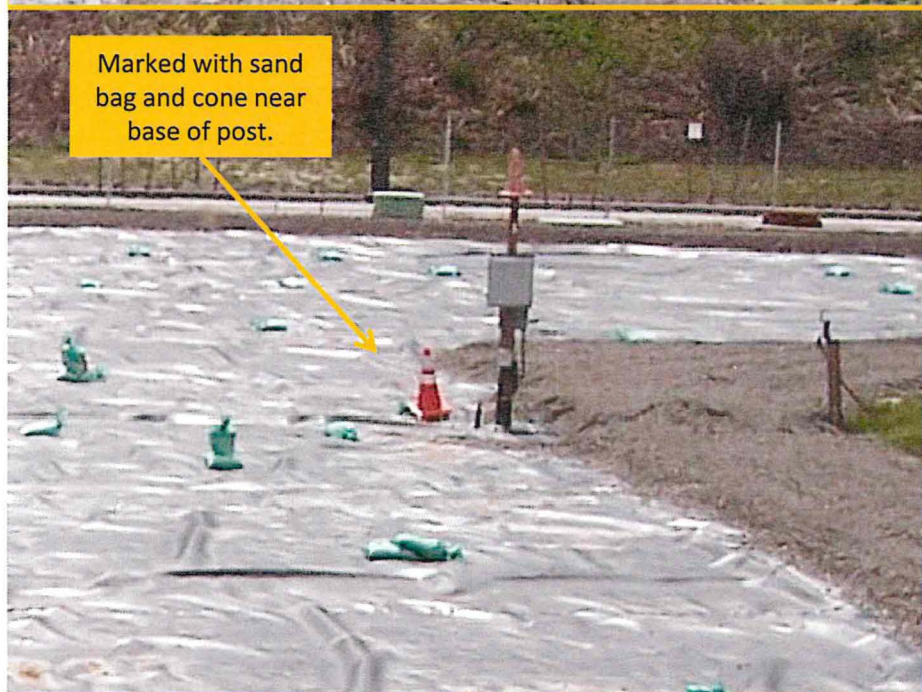
Marked with sand bag and cone near base of post.

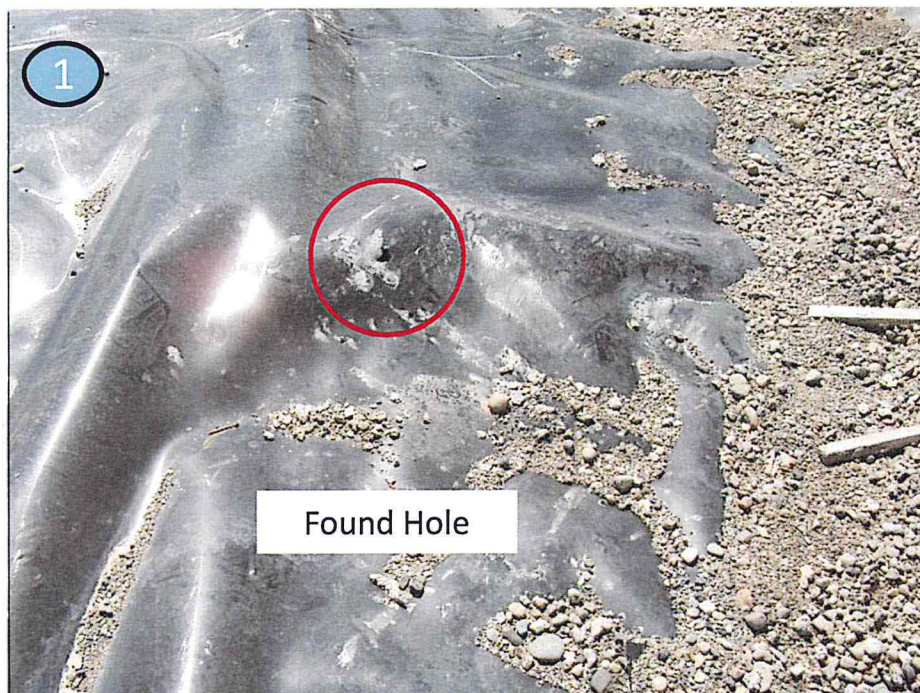
Found Hole

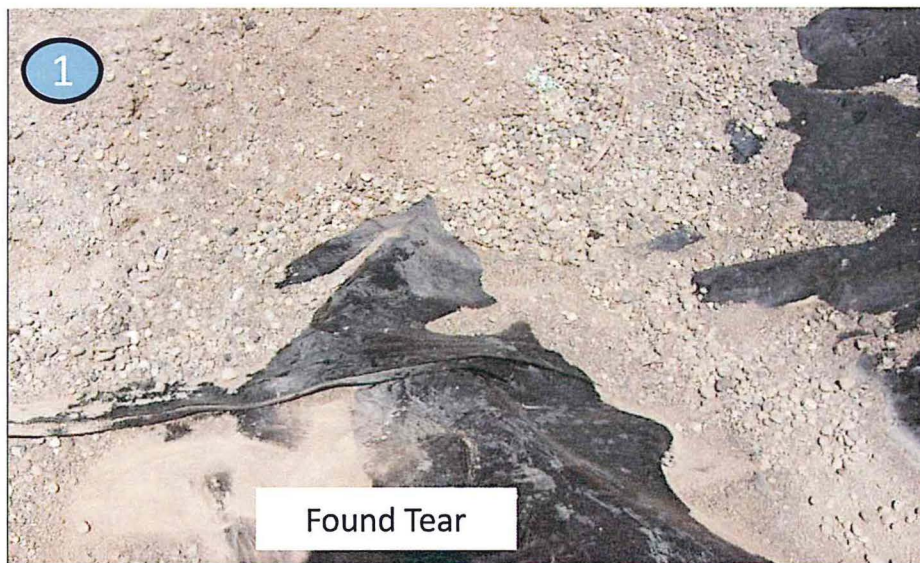
Found Tear

Most of torn area was under the gravel anchor edge.
